Appeal to Halt the Irreversible Destruction of the Kotor Region's Outstanding Universal Value

EXPEDITIO - Centre for Sustainable Spatial Development
The Friends of Boka Kotorska Heritage Society

Annex: Photographic Documentation

The illustrations show the condition of the Natural and Cultural-Historical Region of Kotor in January 2025, mostly through the most problematic example of the settlement of Dobrota.

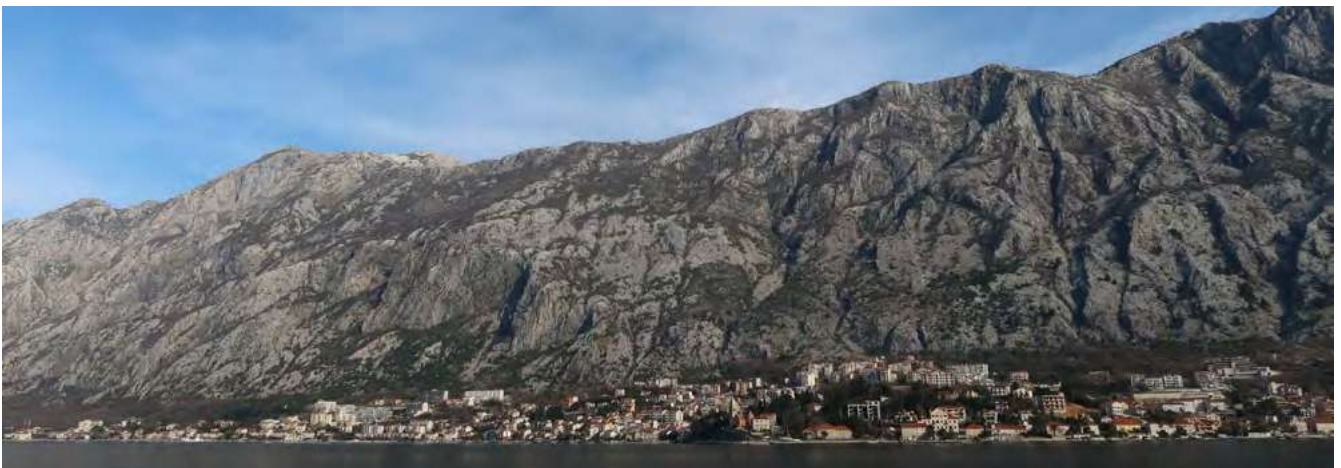
Fig. 1: Above the historic settlement of Dobrota, the characteristic cultivated terraced landscape is almost completely destroyed. The traditional ensembles, baroque palaces, and churches have been entirely buried by contemporary urbanization. Therefore, the characteristic vertical landscape profile and visual landmarks, recognized as attributes of outstanding universal value of Kotor Region, have been completely lost.

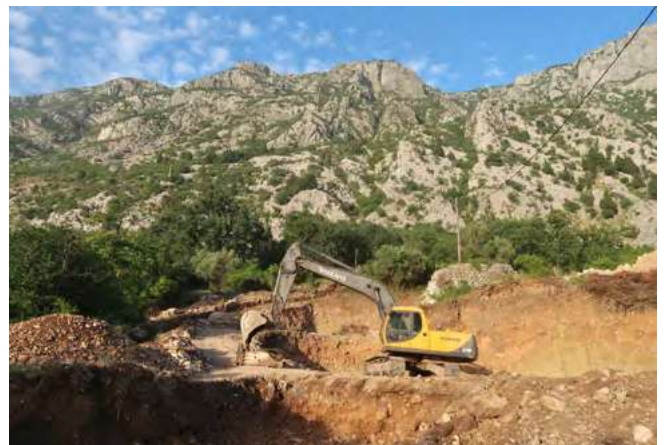
Fig. 2: An example of the complete destruction of traditional terraced landscape in Dobrota is evident in the preparatory works for the construction of a new residential complex in the upper zone of Dobrota, where originally traditional buildings (an old stone house and a threshing floor) and terraced fields were preserved. This zone was not designated for construction in the Cultural Heritage Protection Study, but it was in the Spatial Urban Plan (SUP), and therefore an individual Heritage Impact Assessment (HIA) was required.

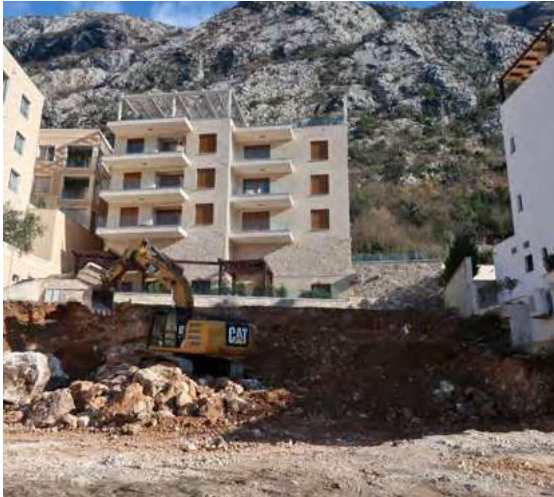
Fig. 3: High density of construction in historic settlement of Dobrota.

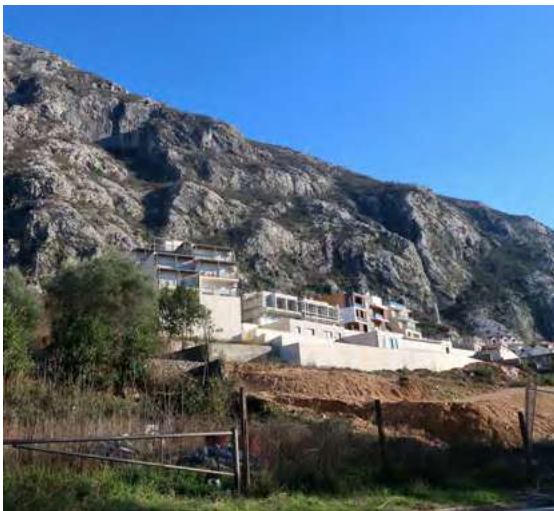
Fig. 5: Zone above Ivanović palace: remains of the cultivated terraced landscape at the left, and the area where new construction is beginning in the already overbuilt area at the right.

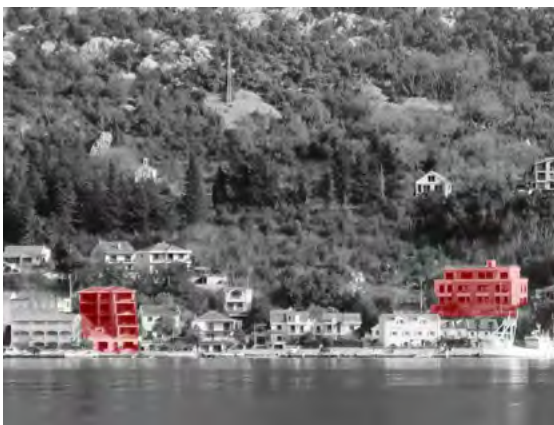
Fig. 7: Another example from Dobrota, below the Church of St. John, where a building under construction with a ground floor and four floors completely surpasses all existing structures. The building at the right, was built in the past two years on cultivated terraced landscape with very ancient oak trees, which have been removed. This building represents an example of structure permitted under the SUP.

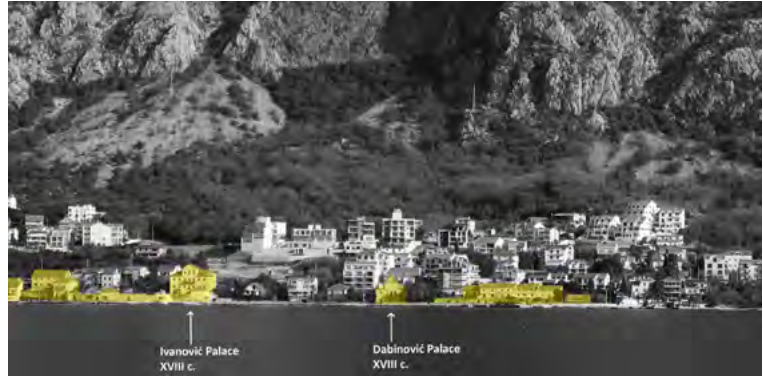
Fig. 4: Part of Dobrota south of the Church of St. Eustace, including the Ivanović and Dabinović Palaces, with marked historic structures and overdevelopment in the zone of terraced landscape. The area around the Dabinović Palace has already been completely overbuilt with excessive density, with buildings of inappropriate size and volume. In the area above the Ivanović Palace, in the recent years large-scale structures have been built, and preparations are underway for the construction of a new residential complex to the right of the palace.

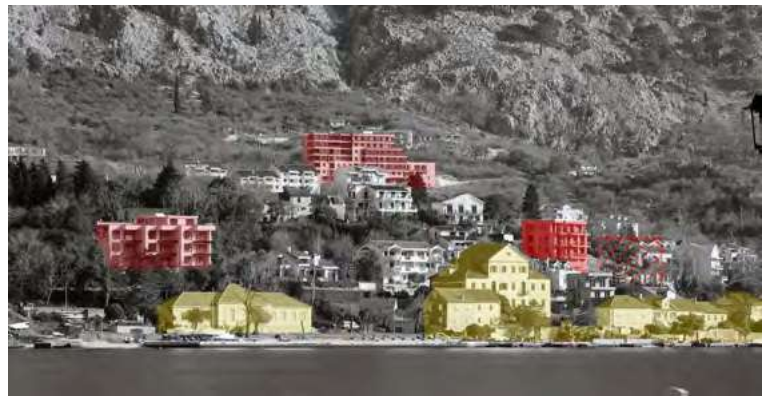
Fig. 6: The historic settlement of Dobrota, south of the Church of St. Matthew, with Milošević palace (early 19th c.) the largest Dobrota palace, along with ensembles of traditional buildings. Yellow - buildings of traditional architecture, including the Milošević palace. Red - oversized structures built in recent years, including the complex currently under construction on the right. In the upper zone, residential houses were built throughout the 20th century, but their density and volume did not significantly threaten the traditional terraced structure. However, the structures built in recent years, as well as those currently under construction, have completely degraded the inherited structure of the historic settlement and the overall landscape due to their high density, volume, and placement.

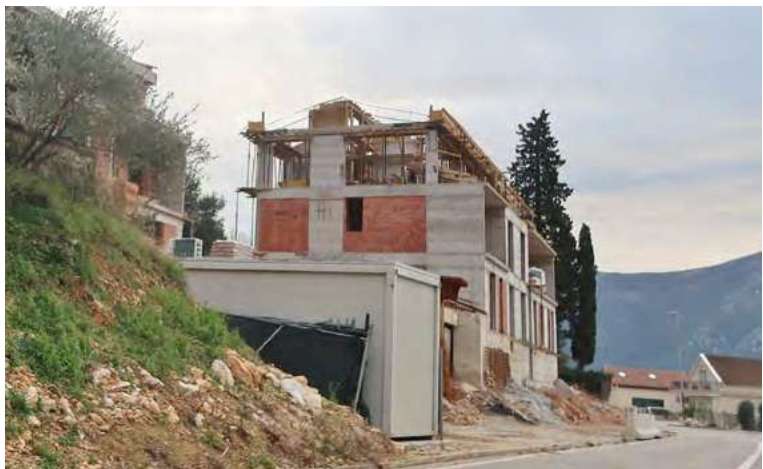
Fig. 8: Example of structures currently under construction in Ljuta under the provisions of the Spatial Urban Plan for Kotor Municipality (SUP). Although the basement should be an underground part of the structure, this is often not the case. As a result, buildings presented in the plan as having just first floor and attic usually comprise four full levels, with large volumes that deviate from traditional structures, and disrupting the historic urban fabric. The largest traditional buildings, palaces, typically feature a ground floor, two floors, and an attic with a belvedere. But those new structures vastly exceed the traditional structures, including even the palaces.

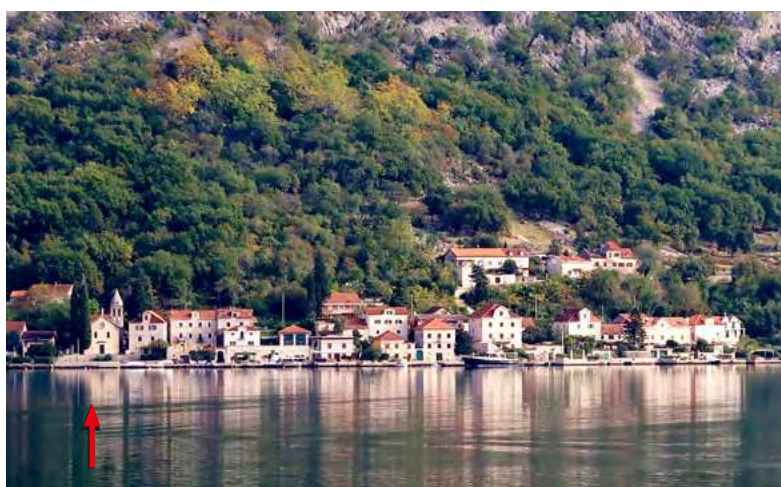
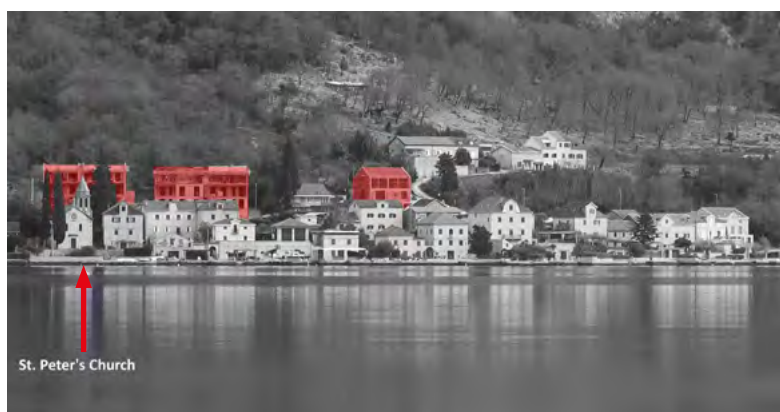
Fig. 9a and b: The historic settlement of Ljuta in 2020 and with new constructions in January 2025. The historic settlement of Ljuta was one of the most well-preserved historic settlements along the coast. However, the buildings newly constructed under the SUP vastly exceed in volume the traditional structures, including even the largest palaces. The most significant complex in Ljuta, the Church of St. Peter, has been visually degraded by new construction behind it.

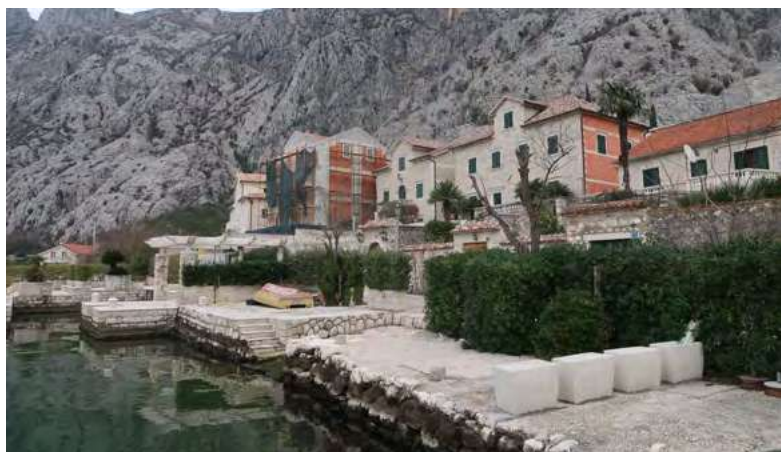
Fig. 10: In the north part of Ljuta, at the first row along the coast, a newly constructed building, interpolated into a row of traditional structures, exceeds the highest traditional building - a small palace - by an entire floor. The approval document for the project states that the building has a three floors P+1+Pk (three visible levels: ground floor, first floor, and attic). However, it is evident that the floor count was not calculated from the coastal road elevation, which should have been a requirement, and the attic was constructed as a full-height floor.

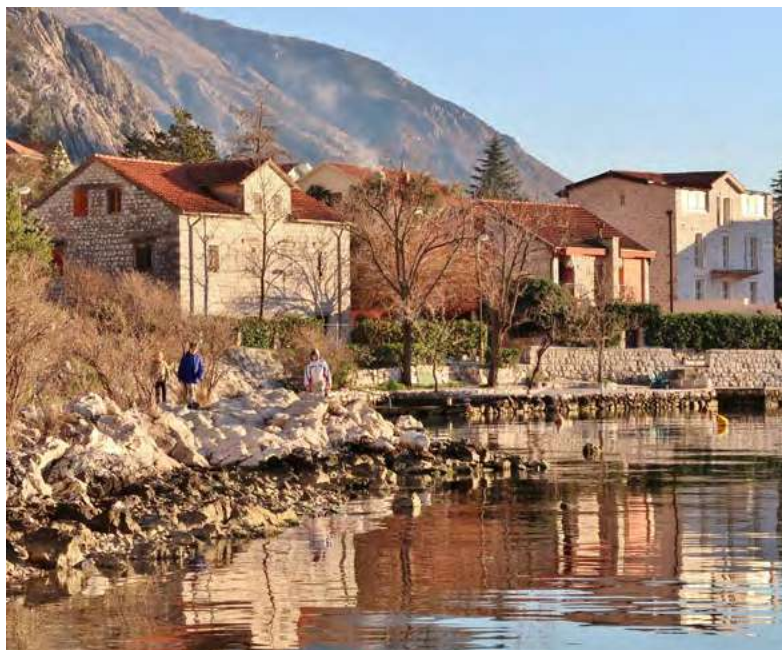
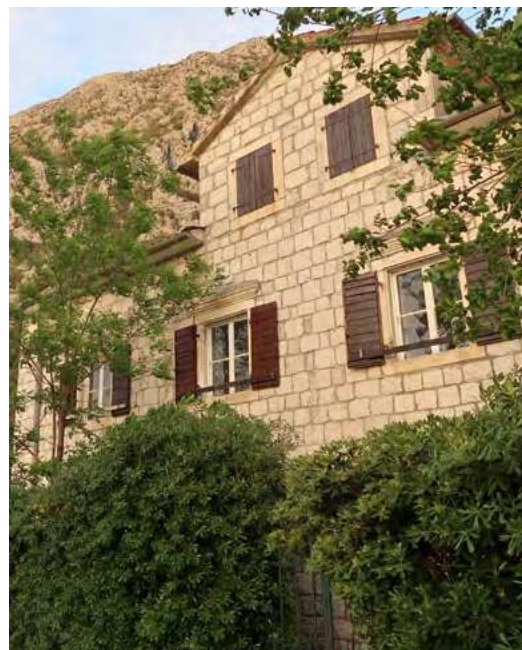
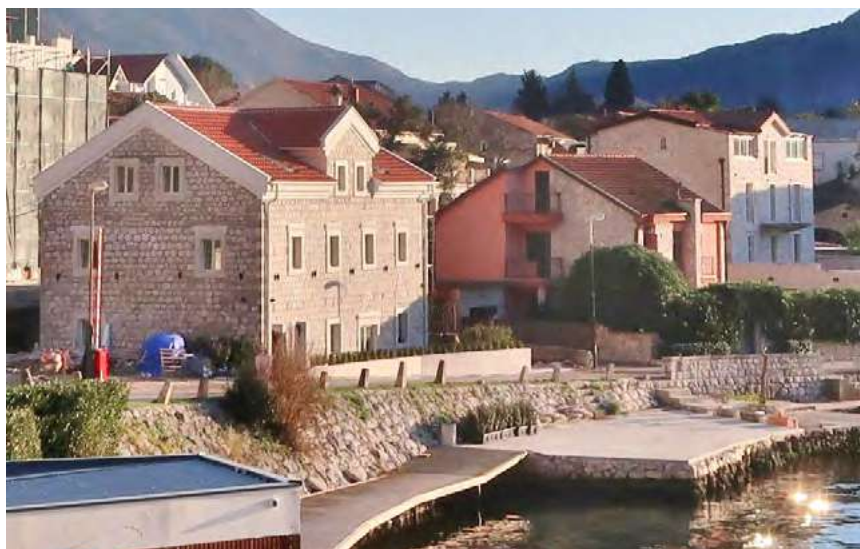
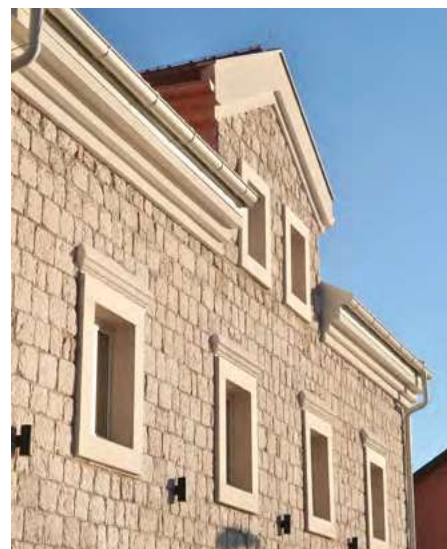
Fig. 11a, b and 12a, b: Kavalin area in Dobrota, and detail of traditional house (2018) and after restoration (2025). Parallel to the new constructions, there are also cases of **inappropriate restoration works** on traditional buildings. In this traditional house, original stone window frames - previously in good condition - were removed and replaced with profile dimensions and stone type that are not in accordance with the traditional ones. The authentic roof cornice was replaced by a new oversized and profiled cornice that is not at all characteristic of the traditional architecture of Bay of Kotor.

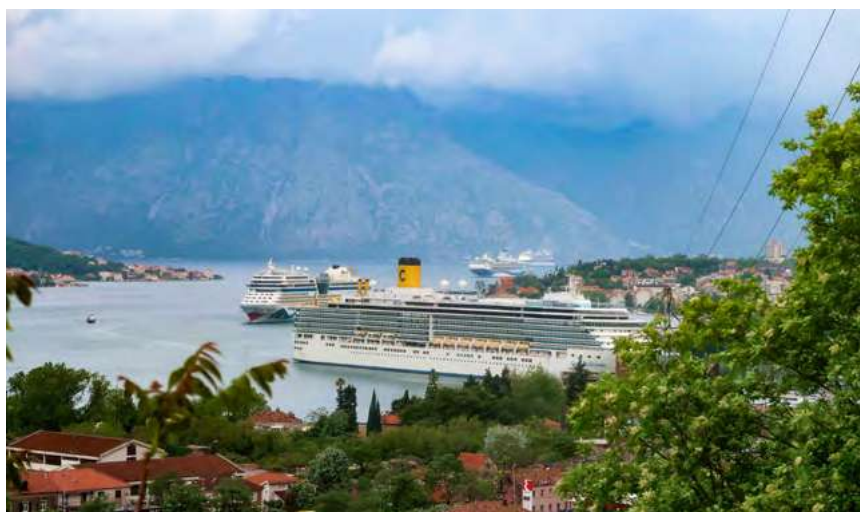
Fig. 13: Overtourism: Four cruise ships anchored simultaneously in the Bay, November 2024
